USAAML TECHNICAL REPORT 65-39

POLYURETHANE AS EROSION RESISTANT MATERIAL FOR HELICOPTER ROTOR BLADES

E. Rouzee Givens

May 1965

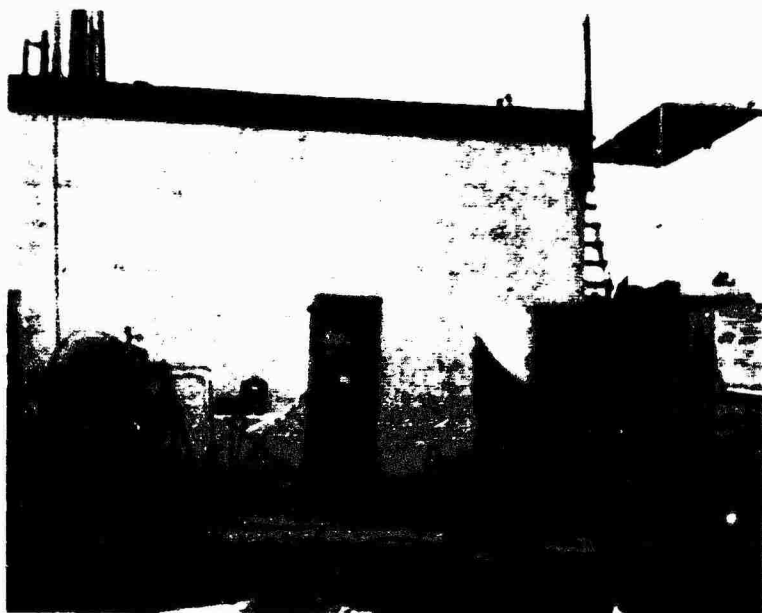
**Figure 1. Whirling-Arm
Rig With Power Source
and Controls.**

To determine the best material to protect the leading edge of helicopter main rotor blades, 184 materials were tested. The test conducted on the most promising materials was a whirling-arm test, which consisted of controlled release of sand from eight bins onto the specimens rotating at tip speeds of 600 and 750 feet per second. Control specimens of .010-inch-thick, full-hard, 301 stainless steel were used on each run for a comparison (see Figures 1, 2, and 3).

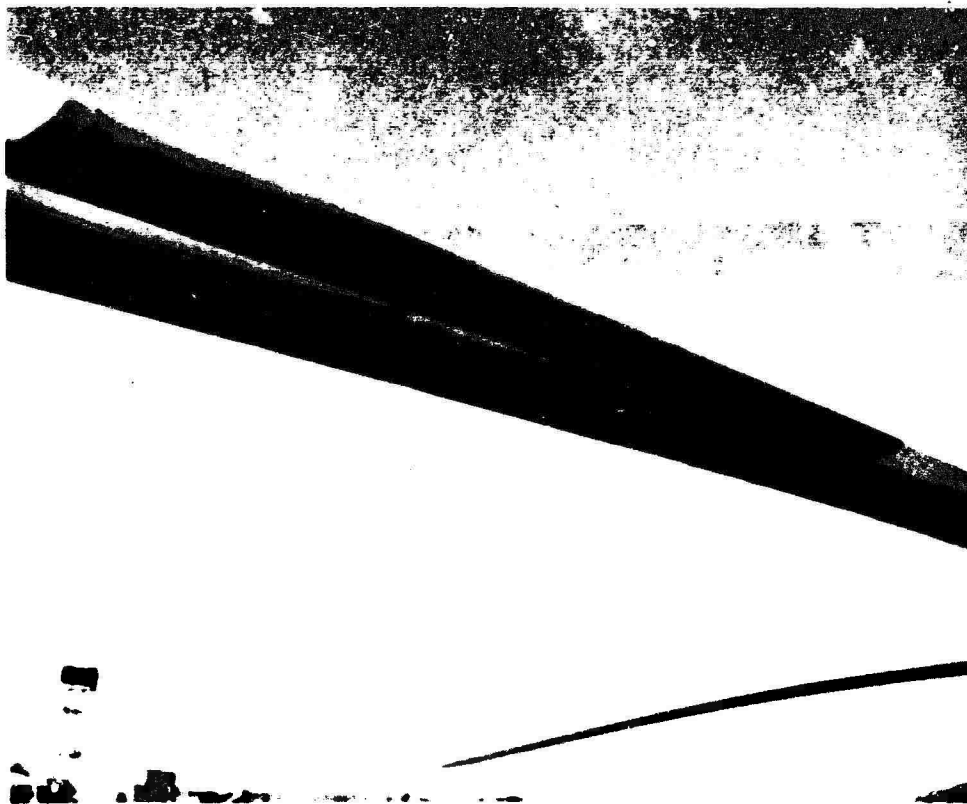
Figure 6. Polyurethane Boot After 1 Year of Service.

A second repair was made to the polyurethane erosion protective system on 19 June 1964 after the blades had 209 flying hours in desert environment. Blisters had developed on blade 58-M-3911. One blister, about 1 inch in diameter, was located 5 inches from the tip and 1/4 inch from the leading edge on top of the blade. Two sand-filled blisters, each 1/4 inch in diameter, were 28-1/2 inches and 32 inches, respectively, from the tip on the bottom side near the leading edge. On blade 58-M-4620, a 3/8-inch-diameter sand-filled blister, 5-1/2 inches from the tip, had developed on top of the blade. These defects were repaired by injecting adhesive Epon 828 into the blisters after the sand had been removed. Liquid neoprene (N-55) was applied over the cut areas and around the faired area of the polyurethane and blade. (See Figures 5 and 6 for condition of boots after 1 year of service and Figures 7 and 8 for comparison of blades after 1 year 8 months of desert operation.)

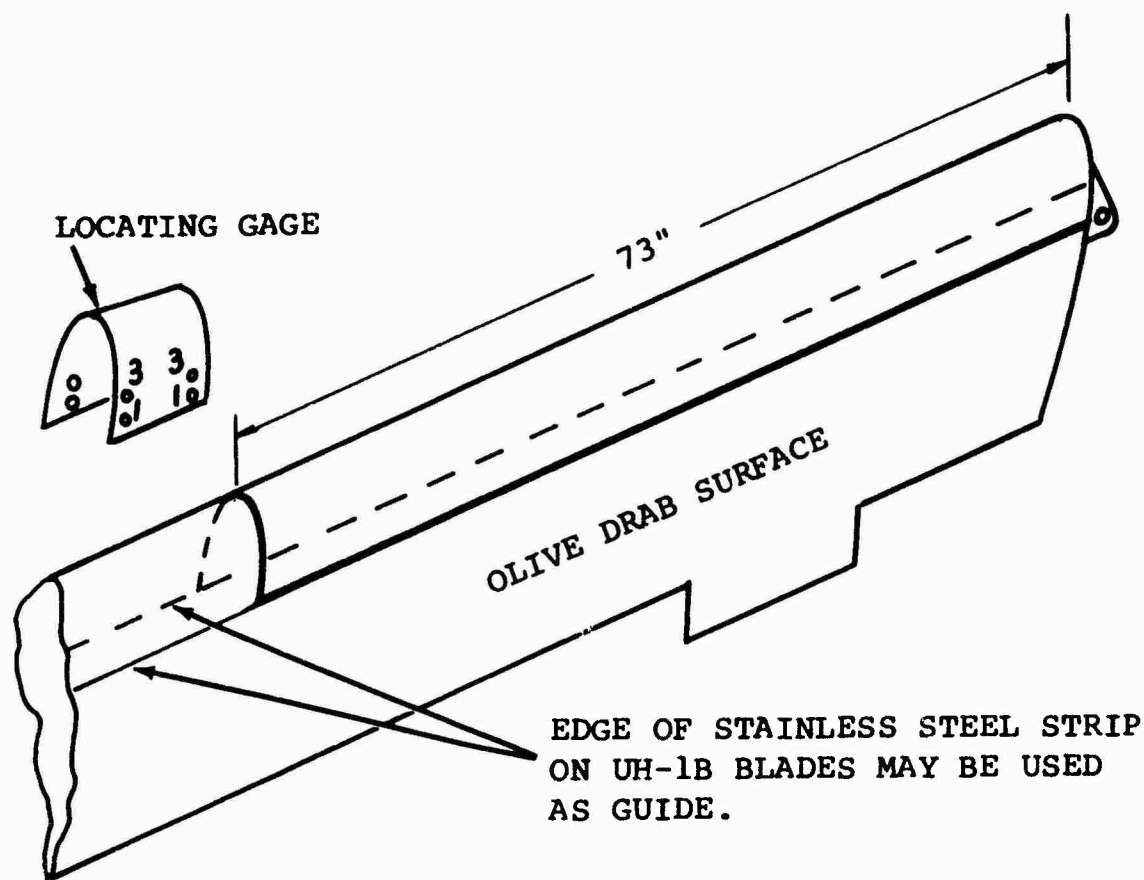
Figure 21. Installation Area

- B. Using a locating gage and a soft pencil, mark off the installation area on the blade as shown in Figure 21.

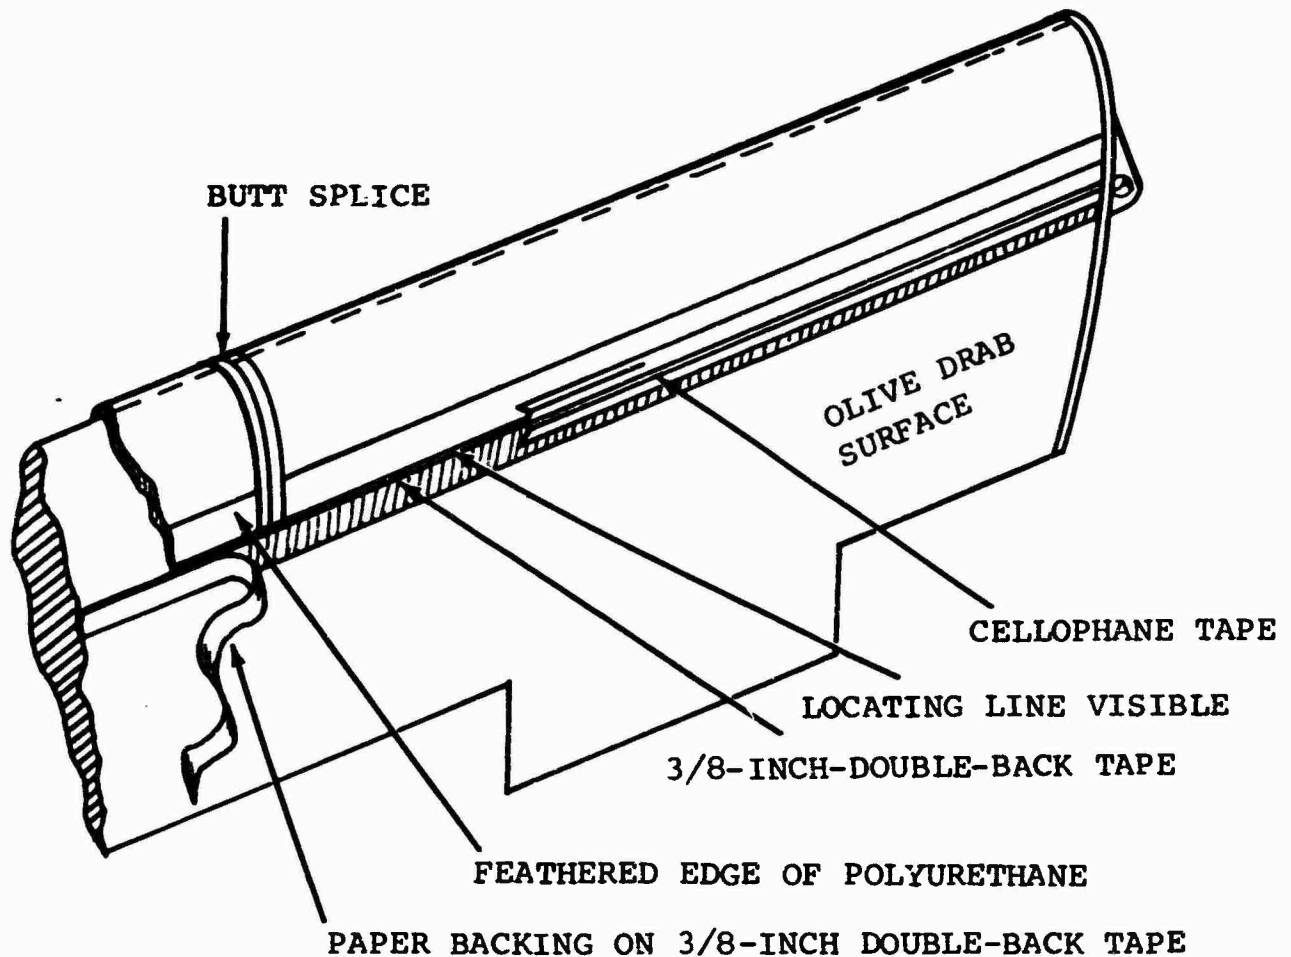
Figure 25. Taping the System in Place

- H. Position the erosion protection system on the blade with the shiny side out and the thick end butting against the edge of the tip cover. Remove the paper backing from the 3/8-inch double-back masking tape. Using clear cellophane tape, attach the erosion protection system to the 3/8-inch double-back tape as shown in Figure 25.
